February 17, 2010

Project C090957

*Results from the
Cursory Structural Assessment of the
Mellon Square Park Renovation Project
Pittsburgh, PA*

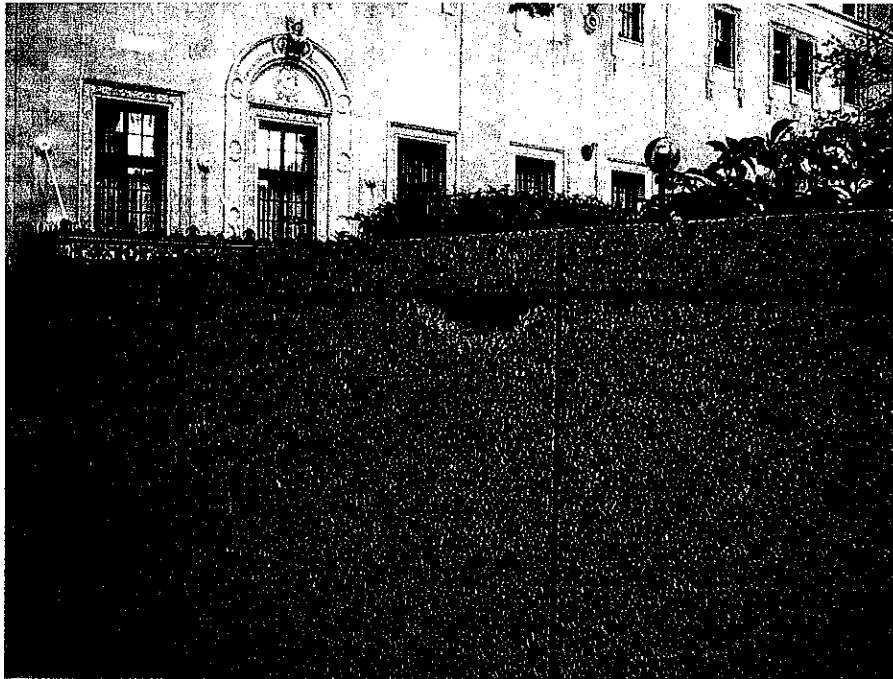
1. The top surface granite panels, bench slabs and coping are generally in good condition. However, there is some cosmetic damage. Approximately 50 panels were observed to have significant chipping (see Photograph 1), seven (7) panels that are completely cracked (see Photograph 2) and one (1) panel missing. There are approximately 23 chipped, one (1) cracked and two (2) missing (see Photograph 3) bench slabs. The coping stones showed the most chipping along the planter edges. This deterioration may be due to people riding their skateboards and/or roller skates along the edges. There are approximately 350 coping stones with significant damage to the outside edges, three (3) stones that are completely cracked and one (1) stone that is missing.

Photograph 1: Significant Chipping of Panel.

5. The stone façade is generally in good condition. We recommend that the crack granite panels be repaired by sealing the cracks with epoxy injection Panels that are chipped should be replaced entirely.

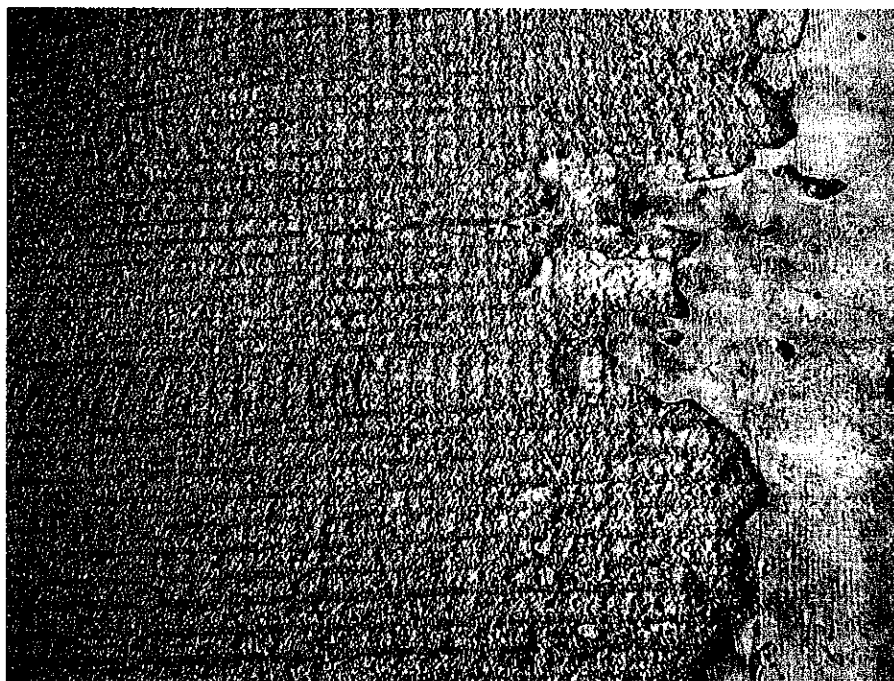
2. 14 stone panels and the coping stones sitting on top of them were removed at 12 locations. Two (2) adjacent panels were removed at two (2) of the 14 locations. The stone facade was removed in order to visually inspect a representative sample area of the structural cast-in-place concrete planter walls. Approximately 1,050 linear feet (LF) of crack (see Photograph 4), 425 square feet (SF) of spall and 625 SF of delamination was observed on the planter and street side walls.

Photograph 4: Crack in Planter Wall

1. The planter and outside walls have some minimal deterioration but in general are in good condition. However, we recommend that spalls, delaminations and cracks in the concrete surface be repaired.

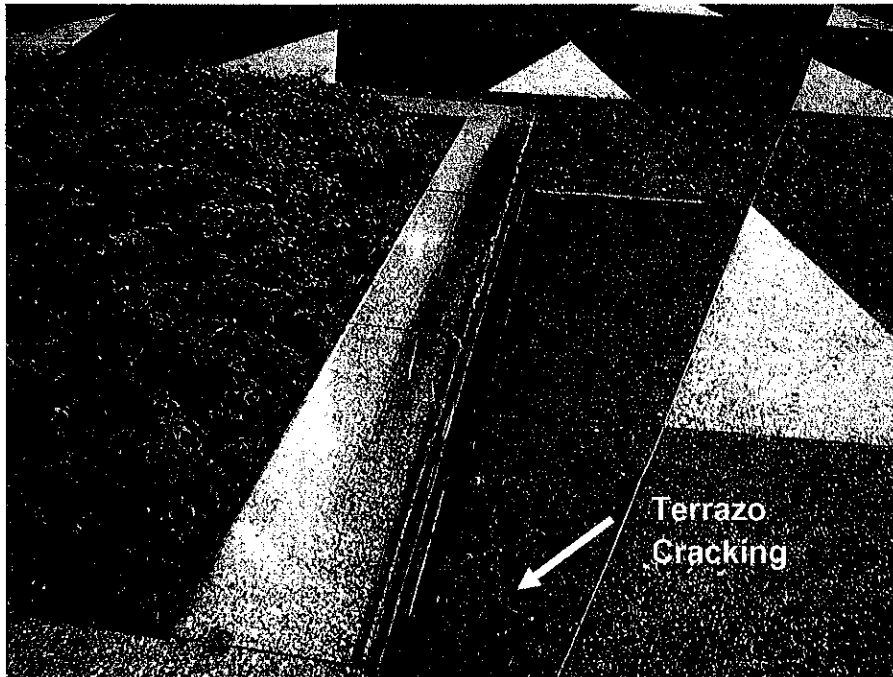
4. The top surface terrazzo pavement and fountain terrazzo is in generally fair condition. There is an estimated 200-300 LF of significant cracking (see Photograph 8) and approximately 150 SF of spalled/patched terrazzo pavement (see Photograph 9). The patches are normal brushed finished concrete and do not match the terrazzo pavement. The cracking in the fountain wall terrazzo exhibits excessive efflorescence (see Photograph 10).

Photograph 8: Typical Terrazzo Cracking. Note Skateboard Damage on Coping

6. The terrazzo pavement shows some wear and tear. We recommend that the deteriorated pavement be replaced.
7. We recommend to add drains at the stair landings to improve the drainage and minimize ponding at the stair landings.

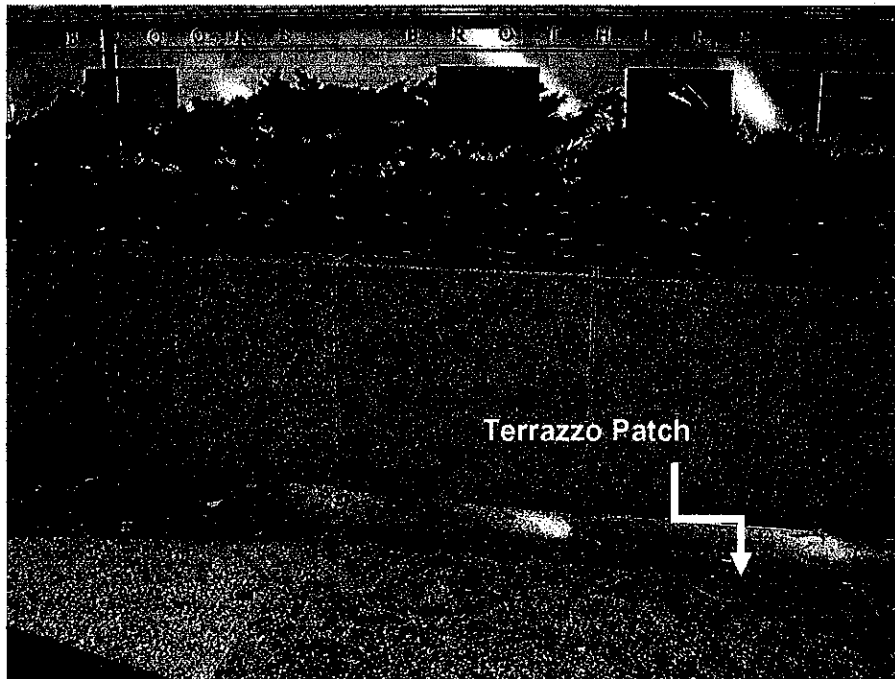
Photograph 9: Typical Terrazzo Patch

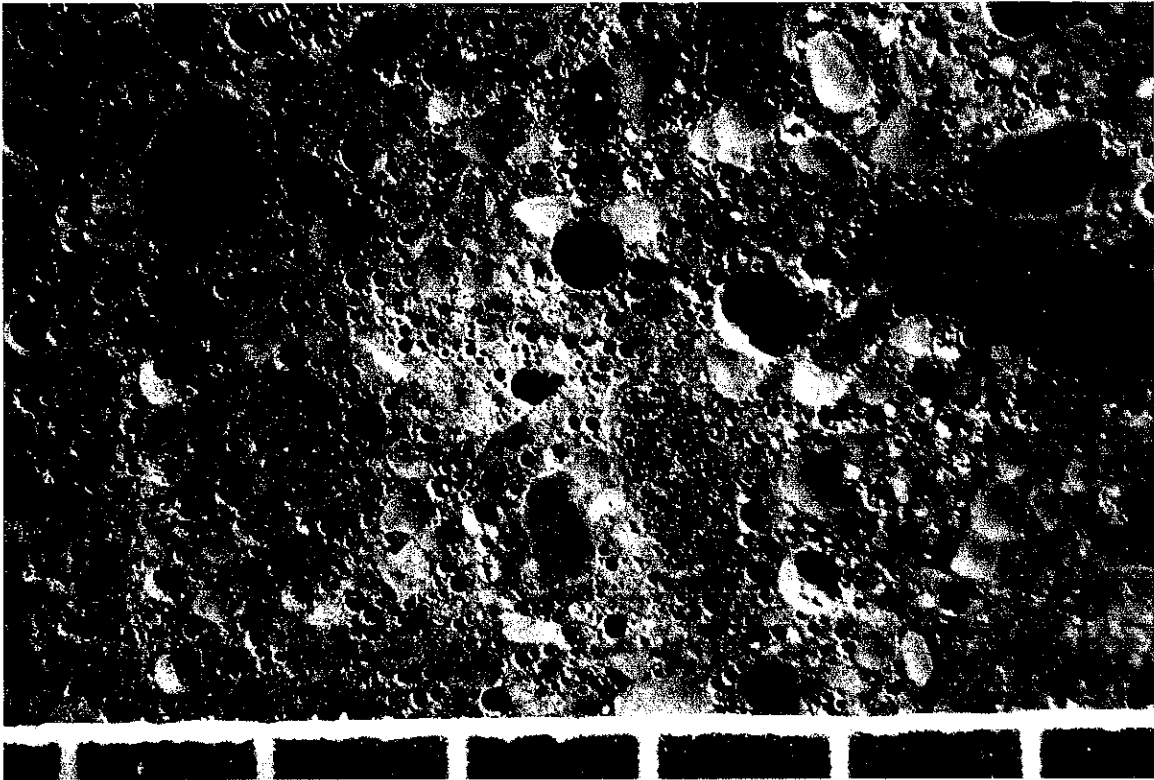
The air content of the concrete is estimated to be from 7 to 8 percent. There are a few small areas of paste present where fine spherical entrained air voids are so numerous that paste has the texture of froth. Secondary deposits of ettringite line and fill many of the voids present at the surface region and throughout the core. A horizontally oriented $1/2$ inch diameter deformed reinforcement is present at a depth of $2^{3/4}$ inches with a perpendicular $5/8$ inch diameter deformed bar immediately below. Both reinforcements are clean and free of corrosion.

Figure 6 – View of the air void system in Core 1. Small areas with numerous voids that give the paste the texture of froth are visible (black arrow) as are the white secondary deposits of ettringite. Increments of the blue scale at the bottom of the image are $\frac{1}{16}$ inch.

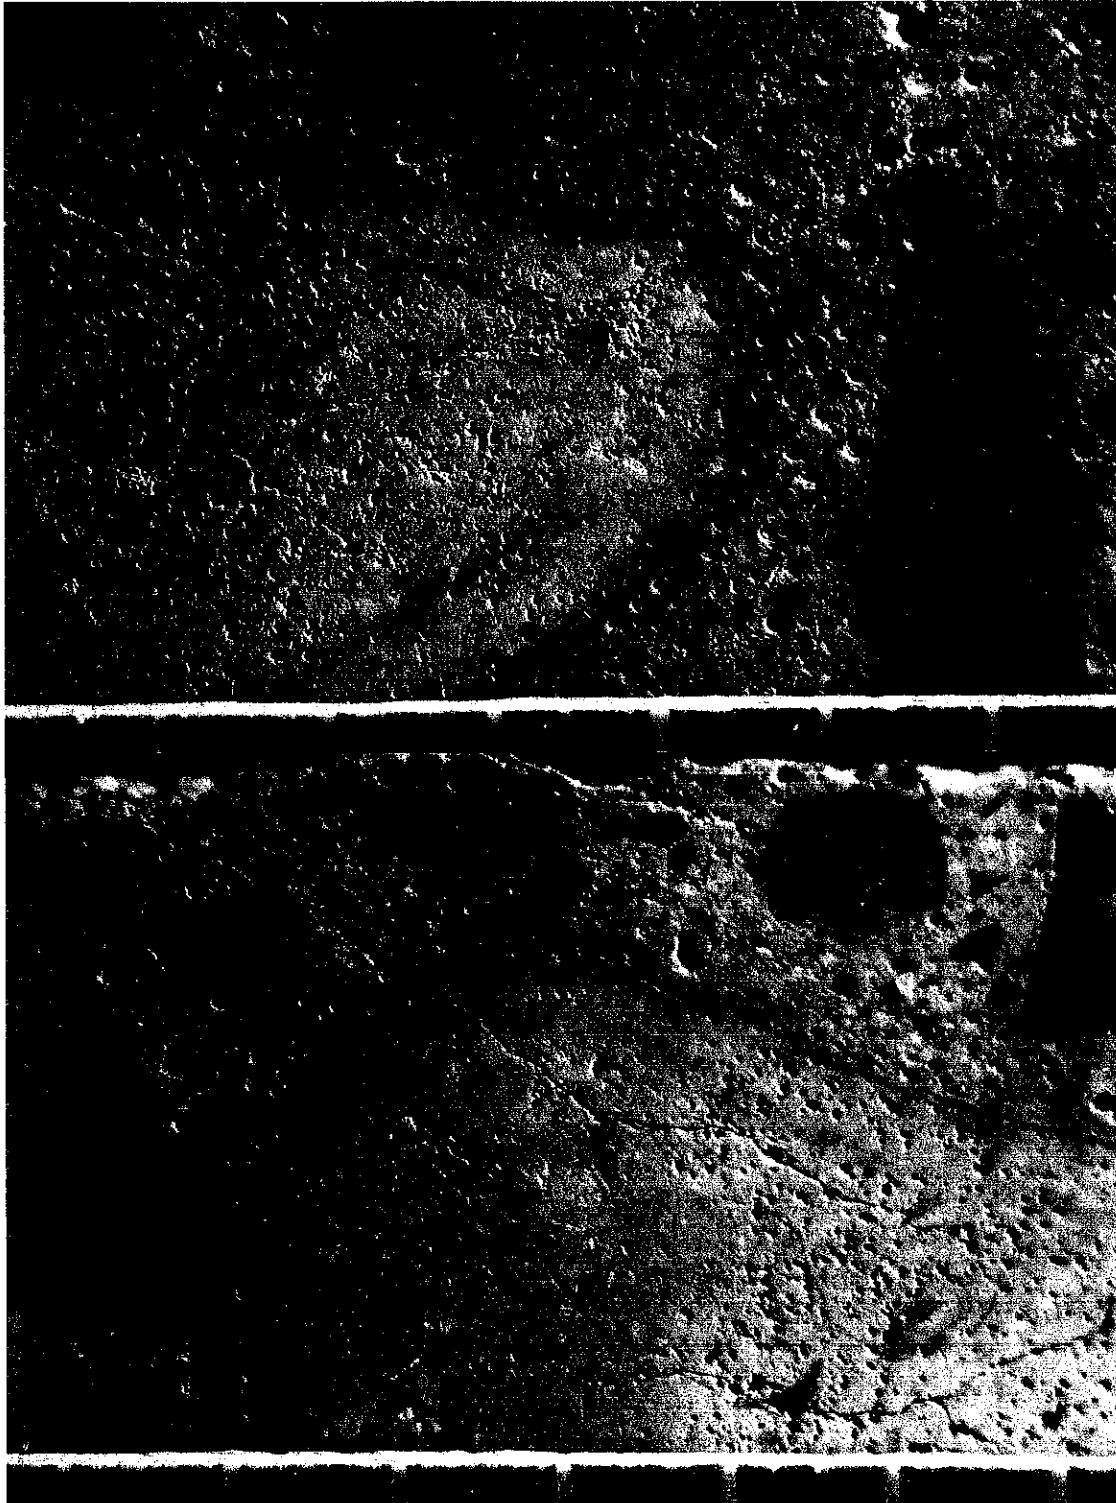
There is a porous chert coarse aggregate particle present just below the top surface of the substrate concrete. The chert particle is cracked and the cracks extend into the flanking paste. Paste immediately flanking the coarse aggregate where cracks extend into the paste have a wet appearance on the prepared surface, but no alkali-silica gel is found. The chert aggregate particle contains chalcedony, which is known to be potentially alkali-silica reactive. No other cracked particles or indications of deleterious reactions are present.

In summary, other than the single cracked particle that is judged to be involved in an alkali-silica reaction, there are no other indications of distress in the substrate concrete. The substrate concrete is well air entrained.

Figure 7 – Views of the cracked chert aggregate particle just below the top surface of the substrate concrete showing the cracks extending into the flanking paste. Increments of the blue scale at the bottom of the images are $\frac{1}{16}$ inch.
