February 17, 2010

Project C090957

*Results from the
Cursory Structural Assessment of the
Mellon Square Park Renovation Project
Pittsburgh, PA*

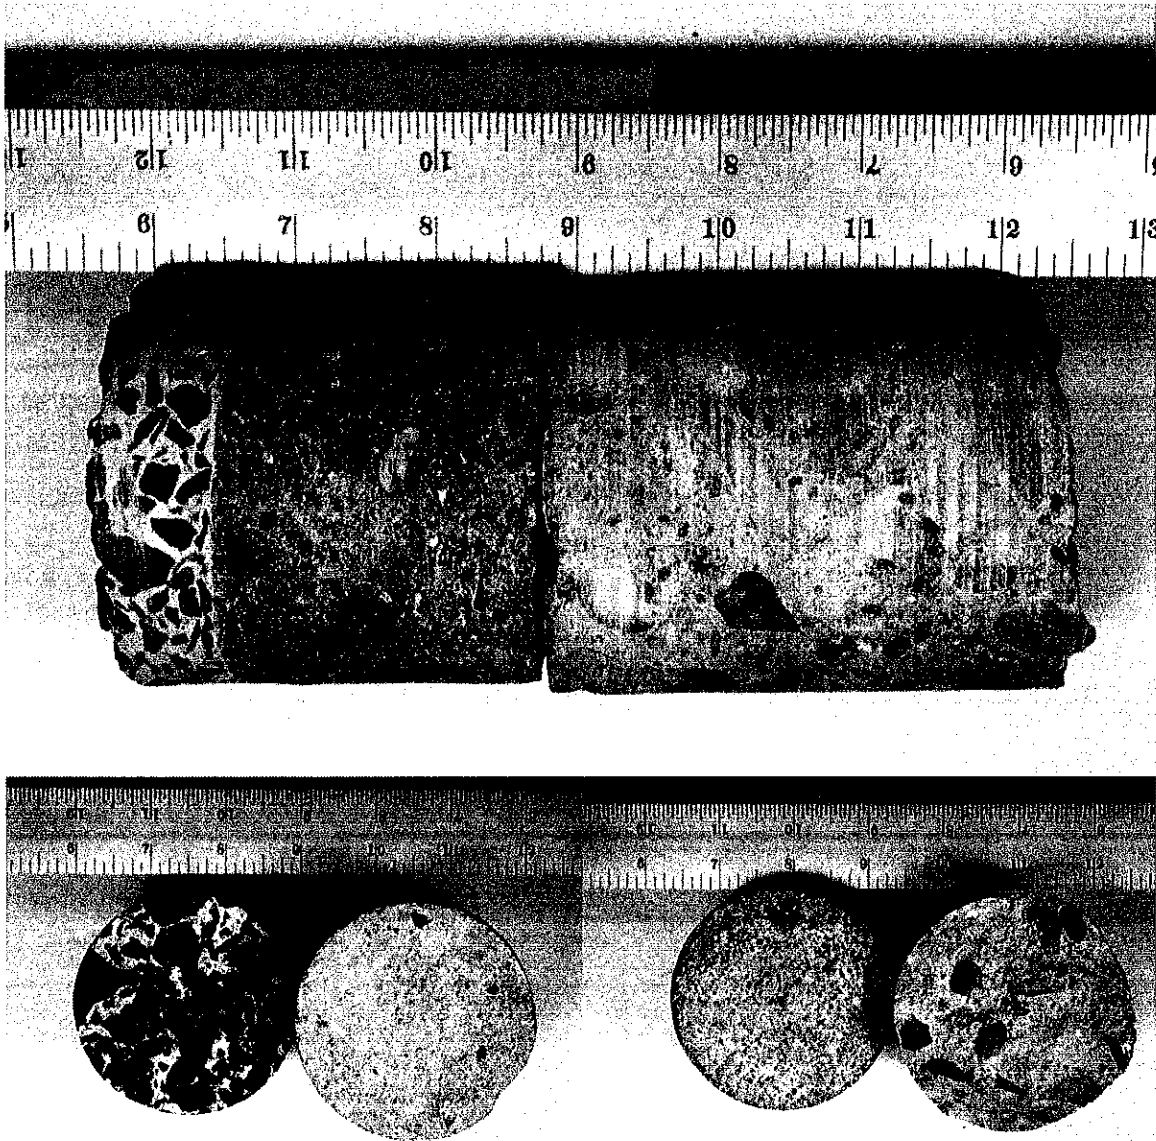
Core 2 is shown in Figure 2 and has a total length of $6\frac{1}{2}$ inches. There are three distinct sections in Core 2; a nominal $\frac{7}{8}$ - inch thick pale green terrazzo topping and wearing surface bonded to a two inch thick concrete underbed that rests on, but is not bonded to a concrete substrate slab. The top surface of the terrazzo is a rough, exposed aggregate surface; the bottom end of the concrete slab section is a fractured surface.

Figure 2 – Views of the side, tops and bottoms of Core 2. The top image shows the side view and three distinct sections of the core; the core is oriented with the top to the left. The bottom left image shows the top surface of the terrazzo (left) and substrate concrete (right). The bottom right image shows the bottom surface of the underbed (left) and fractured bottom surface of the substrate concrete (right).

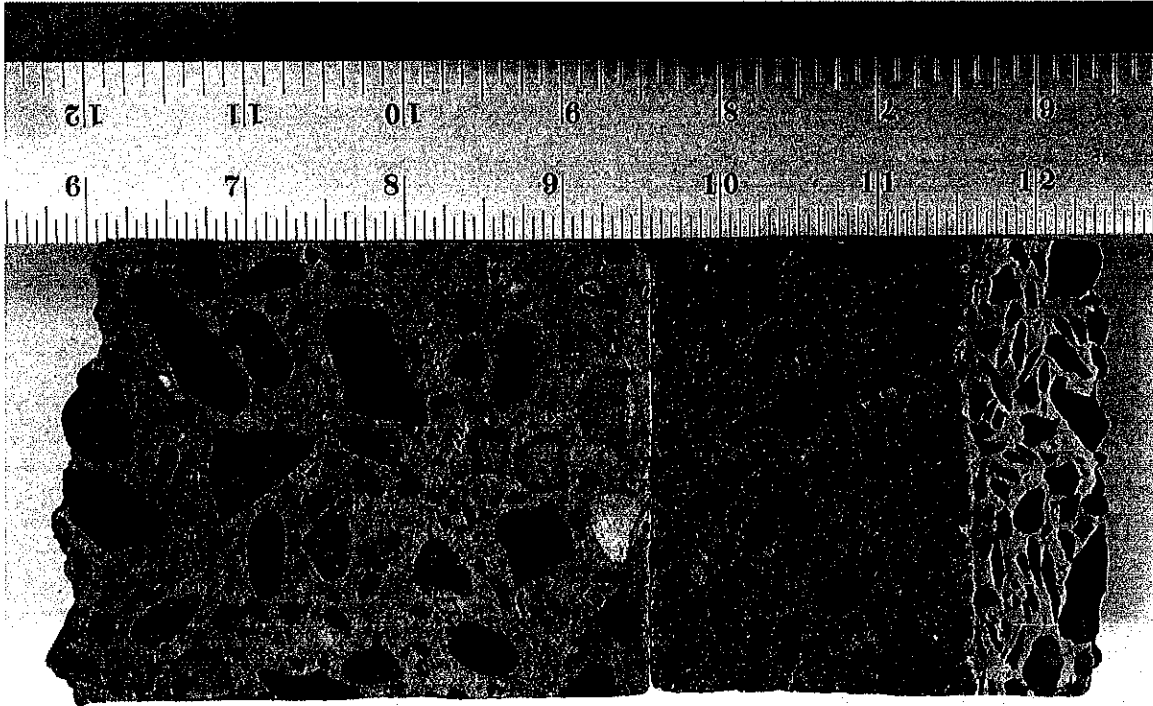
In summary, the underbed in Core 2 is in good condition and is characteristic of underbeds used in terrazzo. There are no indications of distress such as freeze-thaw damage in the underbed.

Figure 4 – View of the prepared cross section of Core 2 showing the three sections of the core. The core is oriented with the top to the right.
